TEST REPORT No. **5576-ZLK/2019**

Degree of protection provided by enclosures.

IP67 tests of lamp enclosure SP-401.

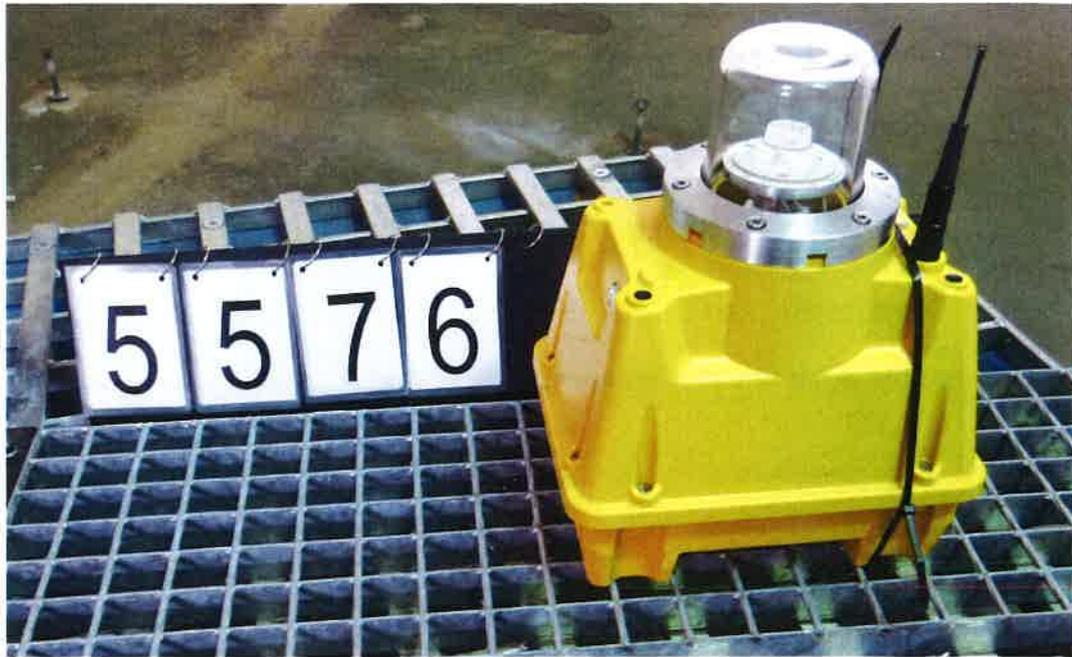
*Fig. 1. Test sample 5576 – before the IPx7 test.*

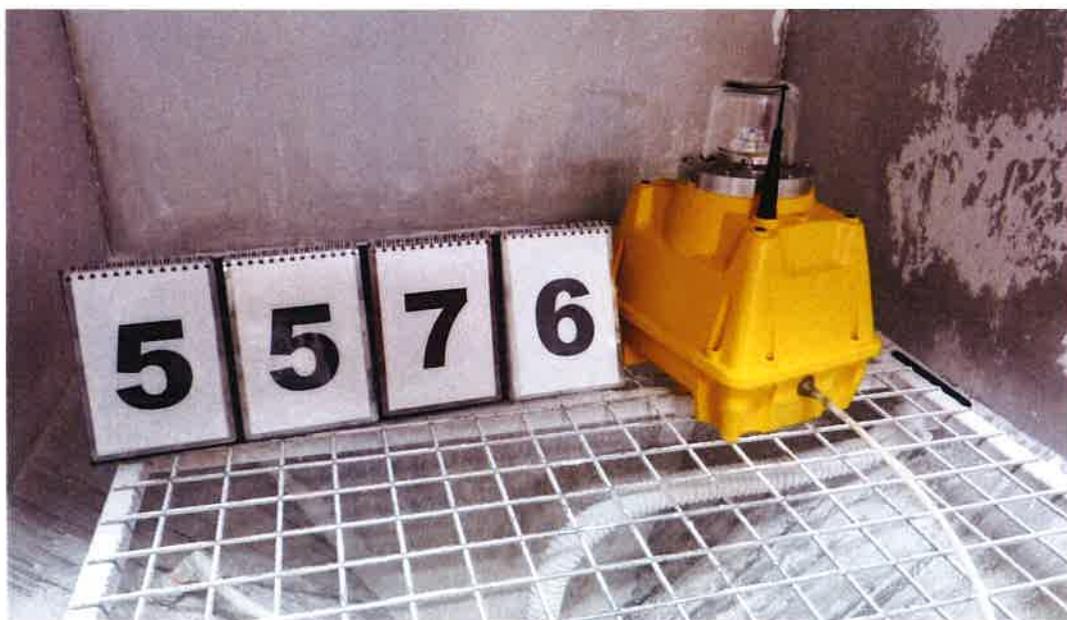
*Fig. 2. Test sample 5576 in the dust chamber – before the IP6x test.*

Test was performed in accordance with the recommendations of PN-EN 60529:2003+A2:2014-07+AC:2017-12, clause 13.4: test IP6x – protection against dust (category 1 enclosure).

- Type of dust: Talcum powder, grain size <75 µm
- The amount of dust: 2 kg
- The dust chamber size: 1 m<sup>3</sup>
- Test duration: 8 h
- Underpressure: 1972... 1994 Pa

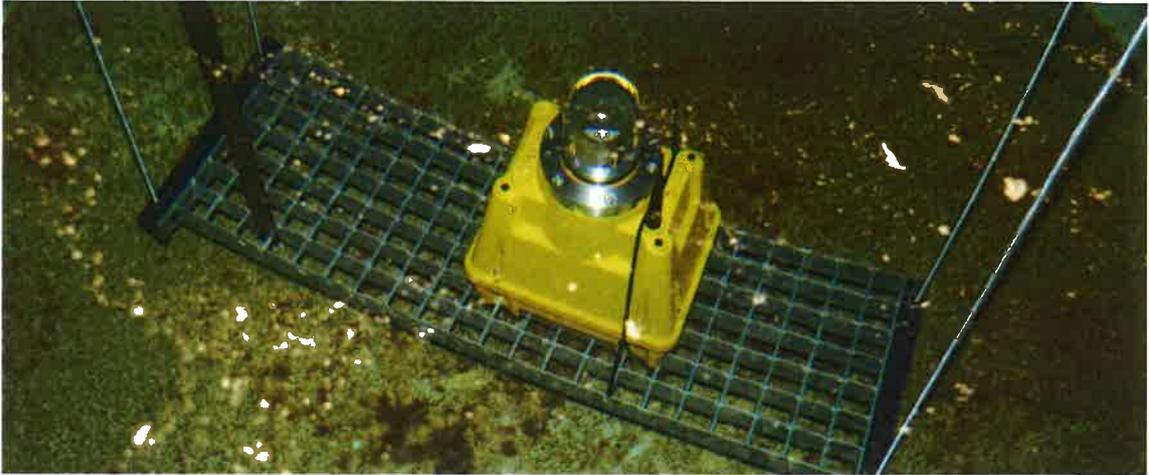
*Fig. 3. Test sample 5576 at the test stand - during the IPx7 test.*

The purpose of the test is to check the device's tightness against short-term immersion at deep between 0.15 m and 1 m. Test was performed in accordance with standard PN-EN 60529:2003+A2:2014-07+AC:2017-12, clause 14.2.7 - protection against water penetration.

- temperature of water: 17,2 °C
- temperature of EUT: 18,7 °C
- test duration: 30 min.

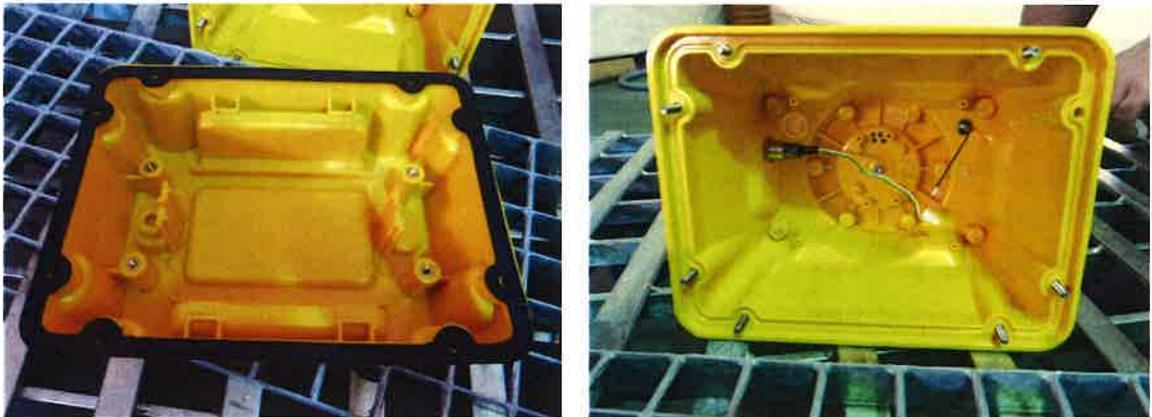
*Fig. 4. Test sample 5576 - Visual internal inspection after the IPx7 test.*

After the test, the EUT was opened and inspected according to the clause 2 of test report (Fig. 4). Water did not penetrate into tested object. Test result positive.

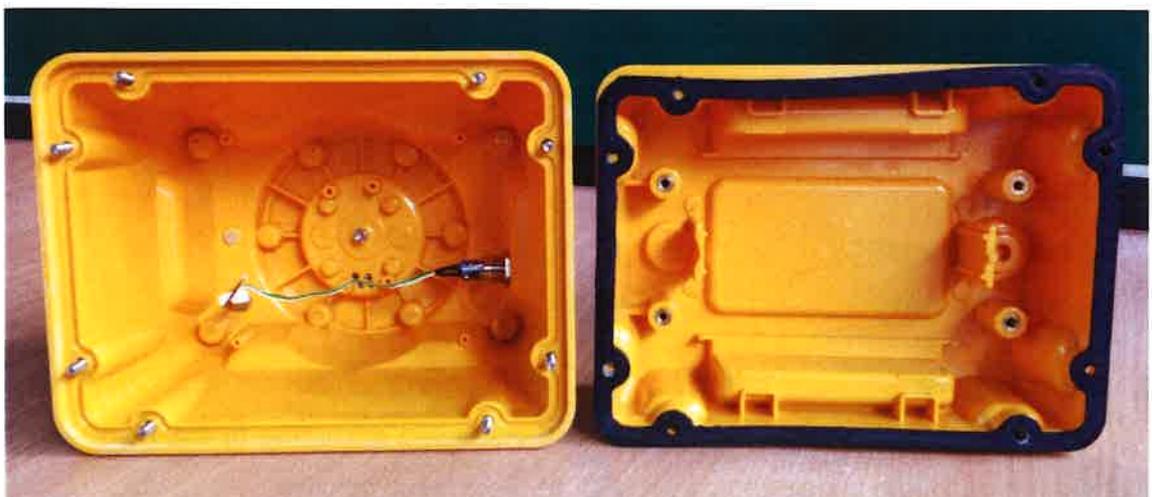
*Fig. 5. Test sample 5576 - Visual internal inspection after the IP6x test.*

After the test, the EUT was opened and inspected according to the point 2 of test report. Dust did not penetrate into tested object (Fig. 5). Test result positive.
